# Features of the fracture of the control valve rod of a thermal power plant steam turbine

Halyna Krechkovska

**Abstract:** The reasons for the failure of the steam turbine control valve rod after 17 years of operation were analyzed. It was found that its fracture began in several places along the perimeter of the rod, followed by coalescence and subsequent spontaneous failure. Fractographic analysis showed that the crack propagated via a high-temperature fatigue fracture mechanism. Impact toughness, strength, and ductility properties determined on axial steel specimens of the control valve rod complied with regulatory requirements. However, the parameters of transverse specimens made from the rod head were lower. A decrease in all these characteristics was also observed in the high-temperature operating zone compared to the low-temperature zone, indicating more intense metal degradation. The control valve rod had 12091 operating hours and 206 shutdowns, which significantly impacted this process. Macrofractographic analysis showed that the rod fracture occurred because of multiple microcrack initiation in the nitrided layer along the perimeter in the zone of the fillet transition

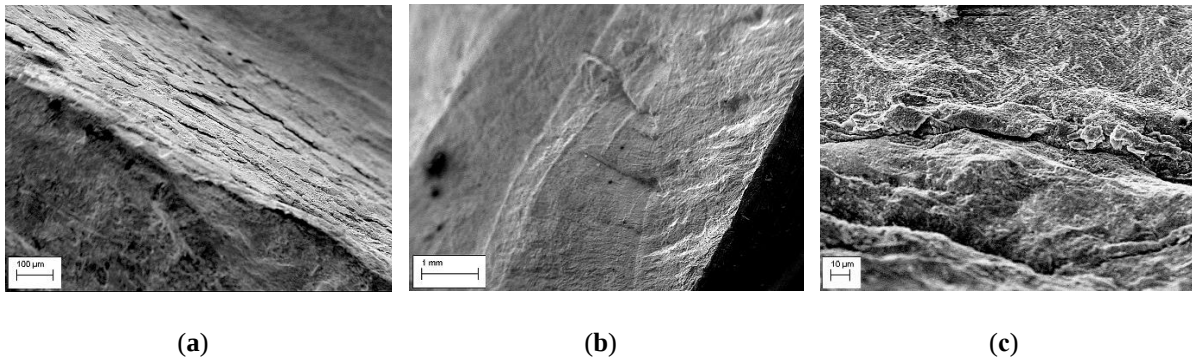
Microfractographic analysis showed that the initiation of a crack in the rod occurred in several places along its perimeter from damage in the surface nitrided layer in the area of the fillet transition between the conical part of the rod and its head (Fig. 1). Damage in the nitrided

layer spread to its entire depth (up to 200  $\mu\text{m}$ ) and caused a high concentration of stresses. This created favorable conditions for the propagation of fatigue cracks in the main metal of the rod. Macro-detail of the fracture indicates that fatigue is responsible for the rod failure. Secondary cracks were observed along almost the entire perimeter of the rod at the transition, which is a sign of weak adhesion between them, which was associated with internal oxidation (Fig. 1c).

**Figure 1.** (a, b) Crack initiation in different zones around the rod perimeter; (c) secondary cracks on the fracture surface.

The fracture of the rod was analyzed macro-fractographically, and it was found that it collapsed due to multiple microcracks in the nitrided layer along the perimeter of the rod, in the fillet transition zone between its conical part and the head, which acts as a stress concentrator. Further, the crack growth occurred in the depth of the section with the merging of the fronts of separate cracks from the surface and the final spontaneous failure of the rod.

Thus, based on the study of the microfractographic features of the control valve rod fracture, it was concluded that it occurred as a result of the nucleation of circular microcracks in the nitrided layer due to its internal oxidation and the destruction of the partitions between the oxidized areas due to cyclic loading of the rod caused by vapor pressure drops, flow turbulence and resonance phenomena, when the natural frequency of oscillations of the rods coincides with the frequency of oscillations caused by the influence of technological factors. The high concentration of stresses at their tops, low resistance to high-temperature oxidation, and matrix destruction (due to the release of chromium carbides and a decrease in its content in the matrix) contributed to their germination into the rod base by the mechanism of multi-cycle fatigue. If the niobium present in the steel composition had performed its assigned function (to prevent a decrease in the chromium content in the matrix), the rod resource would have been much greater. Therefore, in the future, to prevent unforeseen damage to such critical structural elements as rods, incoming inspection of the steel structure is recommended.

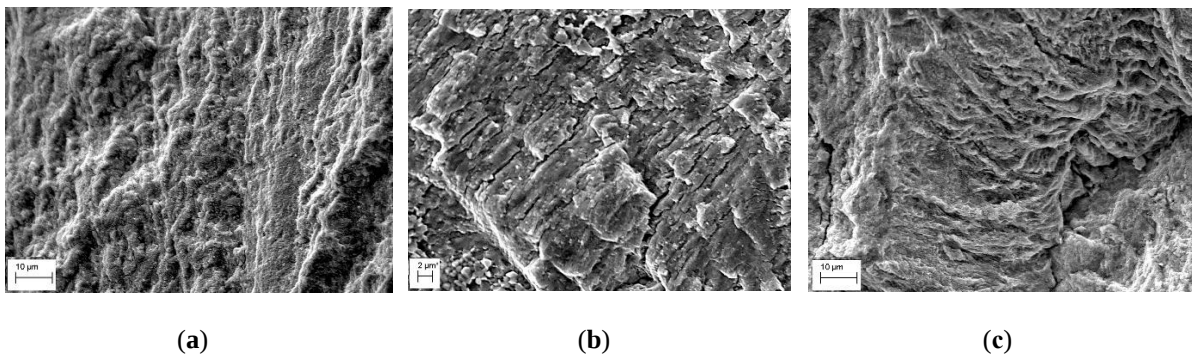
Within the nitrided layer, fatigue failure of the partitions between the fragments separated from the matrix by internal oxidation occurred, with the formation of a grooved relief oriented parallel to the outer surface of the rod and with signs of secondary cracking (Fig. 2 a). In areas corresponding to decohesion zones due to internal oxidation, traces of corrosion effects on the interphase boundaries between the matrix and inclusions of various nature were identified.

**Figure 2.** Microfractograms of rod fracture: (a) in the area of the surface nitrided layer; (b) at the stage of stable fracture propagation; (c) in the crack growth zone with high asymmetry of the loading cycle (at the stage of low-cycle fatigue).

At the initial stage of the transition of the fracture to the base metal, fatigue cracks originated from the blunted crack tip in the nitrided layer by forming a smooth relief with barely noticeable fatigue grooves. By the step of the grooves, it was established that at the initial stage of crack growth in the rod, their speed was  $5 \cdot 10^{-8}$  m/cycle. With increasing crack length, the contours of the grooves became increasingly clear, their step became larger, and the festoons, the surface of which was covered by the grooves, became more

relief. These are signs of an increase in the crack growth rate. The classical groove mechanism of fatigue failure was preserved in most of the rod fractures, which is usually considered a sign of multi-cycle fatigue (Fig. 2 b). Of course, the deeper the fracture spread from the lateral surface of the rod, the greater the pitch of the grooves, the deeper and clearer the secondary cracks that decorated them, and the greater the relief of the festoons.

Fatigue fracture in the base metal occurred with significant signs of plastic deformation, delamination, formation of chevron patterns, and track marks (Fig. 2c). It was assumed that the prerequisites for such a fracture arose due to the deepening of cracks in other places along the perimeter of the rod under conditions of multi-cycle fatigue. As a result of low-cycle fatigue, only the alignment of the fracture front occurred.
