STRUCTURAL-FRACTOGRAPHIC INDICATORS OF OPERATIONAL DAMAGE IN STEAM TURBINE ROTOR DISC STEEL

Abstract. *The technical condition of the metal in a steam turbine rotor disk was analysed, and the causes of its failure were determined. It was shown that, despite the mechanical properties of 30KhN3M1FA steel meeting regulatory requirements under tension and impact, damage occurred in one of the rotor stages, leading to a forced shutdown of the rotor. Metallographic studies of the steel structure revealed an excessive amount of non-metallic inclusions, the high corrosive activity of which facilitated the dissolution of the matrix in their vicinity. These point defects became the sites of fatigue crack initiation. High contact stresses between the surfaces of rivets and holes in the rotor disk, and the constant increase in their relative displacement due to clearance violations during long-term operation, contributed to contact fatigue and the initiation of a network of microcracks in the vicinity of the holes. The string-like arrangement of structurally determined corrosion defects facilitated their coalescence, forming a continuous fatigue crack front. Its propagation culminated in the

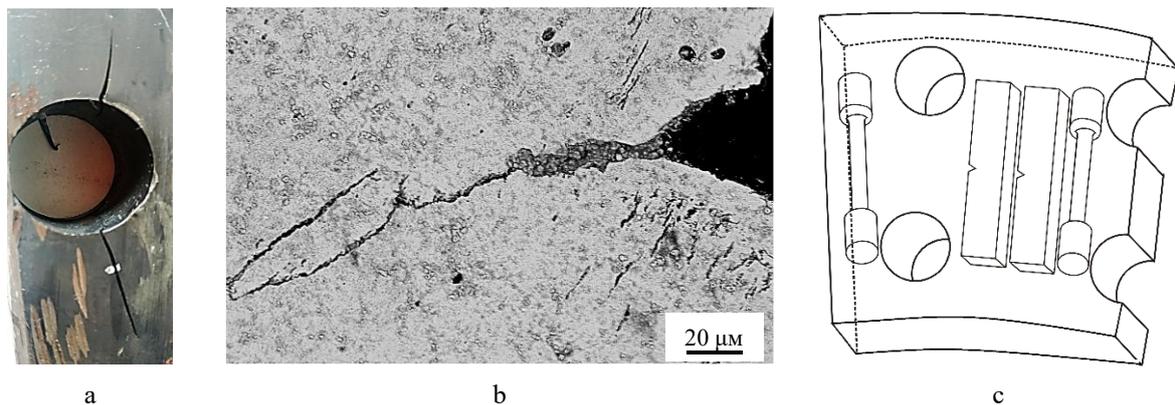
The fractures on the rotor disc's crest were located between adjacent rivet holes connecting the forked blade roots to the rotor disc's crest. Macroscopically, the cracks that developed in the bridges between the holes in the disk crest were oriented normally to the direction of the centrifugal forces generated during rotor operation. In the diametrical cross-section of these bridges that had not yet completely failed during operation, cracks originating from the rivet holes were detected (Fig. 1 a). At the microscopic level, these cracks were characterized by both macro- and micro-branching and a curvilinear propagation path (Fig. 1 b). Furthermore, the gap between their edges was filled with corrosion products formed as a result of the interaction of steel with the process medium during prolonged contact. All these signs indicate that the failure of the bridges between the holes occurred via a corrosion-fatigue mechanism, rather than as a result of spontaneous failure due to a single rotor overload. Taking into account the orientation of the operational fractures on the rotor disc crest, the mechanical properties of the steel were determined using specimens oriented radially relative to the rotor axis (Fig. 1 c). This was done to ensure that the macro-orientation of the specimen fractures and the operational fractures of the disk coincided. The results of the mechanical tests on these specimens showed that their σ_{UTS} and σ_{YS} values were 773 and 653 MPa respectively, δ and ψ were 22 and 71%, and KCV was 1,64 J/cm². All these indicators did not exceed the requirements of the industry technical specifications TS 108.11.918-87. Thus, despite the compliance of the rotor's operating conditions, the steel's chemical composition, and its mechanical characteristics with the regulatory requirements, the rotor disc still failed.

Figure 1. Macro- (a) and microscopic (b) view of cracks from a rivet hole and scheme of cutting samples (c) from the crest of a steam turbine rotor disk

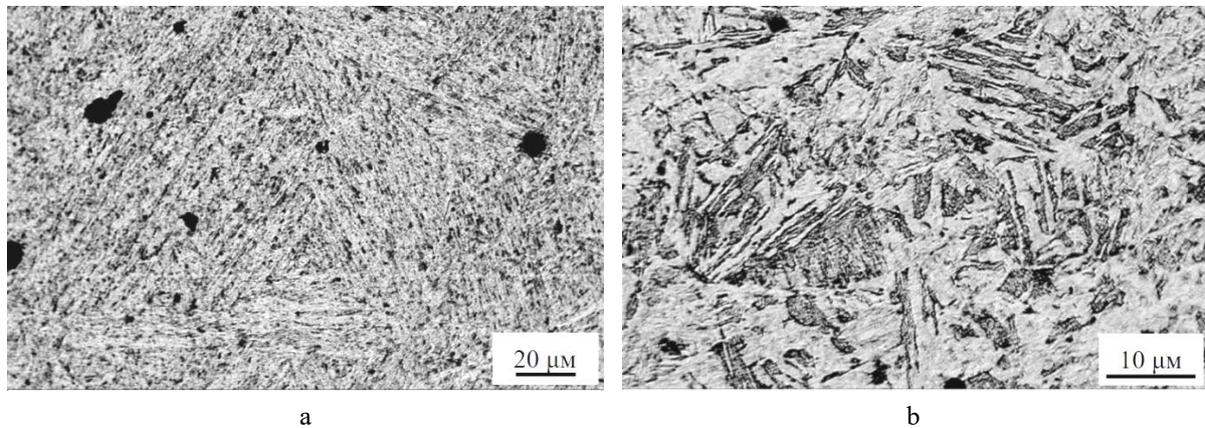
Metallographic studies of the structure of 30KhN3M1FA steel in the diametrical cross-section of the disc revealed typical morphological signs of highly tempered martensite (Fig. 2), which were more clearly identified at high magnification. The characteristic orientation of packets of practically parallel martensite laths changed during the transition from one austenite grain to another, within which they were formed. A feature of the structure was also an excessively high number of quite large (up to 15 μm) non-metallic inclusions, the high density of which was more clearly revealed at lower magnifications (Fig. 2 a). In the structure of the analyzed disc, their density was several times higher than the acceptable value for rotor disc metal (up to 2–3 particles per 1 mm² of polished surface area).

Figure 2. Structure of 30KhN3M1FA steel in the diametrical cross-section of the rotor disk crest

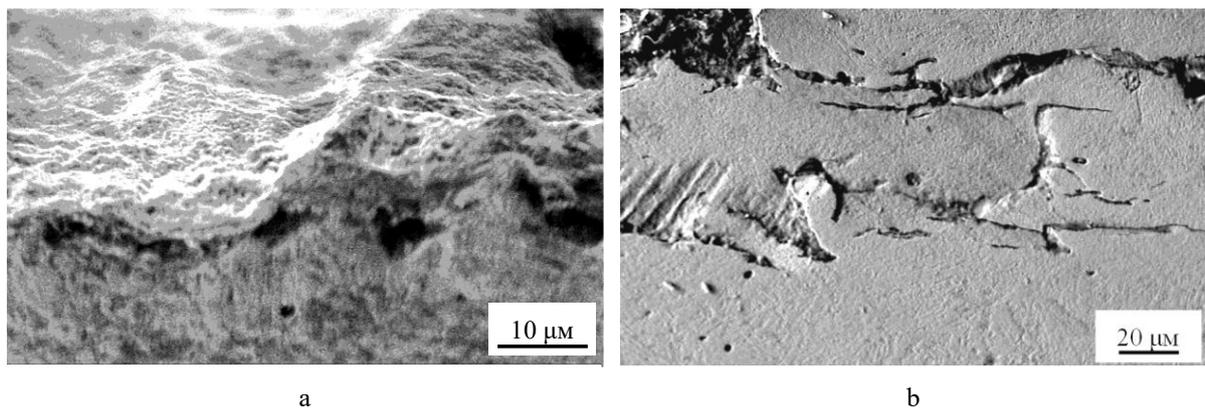
of these inclusions created the preconditions for the localization of deformation processes in areas with their high density. Indeed, the corrosive pits that formed on these inclusions (due to the dissolution of the inclusions themselves or the matrix around them) acted as structural stress concentrators. They were observed even near the transitions from the surface of the rivet holes in the disk crest to the surface of its fracture in the form of unidirectional rows of corrosive defects connected by a crack parallel to the fracture and located directly below it (Fig. 3 a).

Figure 3. Banded arrangement of corrosion pits of corrosive pits initiated by non-metallic inclusions on the surface of the rivet hole (in the lower part of the image), in the vicinity of its transition to the operational fracture surface (a), as well as typical contact fatigue cracks found on the diametrical polished section of the rotor disc crest under the surface of the rivet hole (b)

Such cracks are typically associated with contact fatigue. They are usually inclined relative to the contacting surfaces, and therefore, in cross-section, they appear parallel to them. The growth of contact fatigue cracks occurred through the destruction of the bridges between the closest non-metallic inclusions, which confirmed their negative role in the nucleation of damage (Fig. 3 b). Both the number of such cracks and the depth at which they were detected under the hole surface increased closer to the zone from which the disc crest failure occurred. Due to the action of high contact loads, cracks located at various distances from the hole surface in the disc crest connected via a shear mechanism, destroying the bridges between the nearest non-metallic inclusions. The transformation of one of these cracks into a main crack was accompanied by its reorientation (to one radially oriented relative to the rivet hole) and subsequent propagation under the action of cyclic tensile loads, but now as a crack oriented normally relative to the direction of the centrifugal forces acting on the disc.

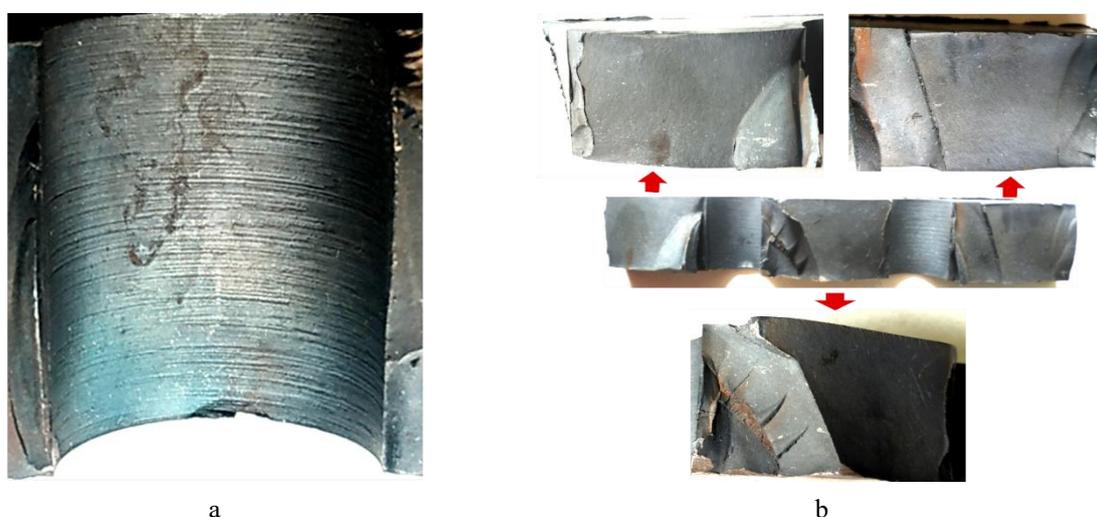
During the visual inspection of the damaged elements of the disc crest, traces of contact fatigue were also found on the inner surface of the rivet holes in the damaged disc, in the form of a crack on the steam inlet side to the stage (Fig. 4). The crack is oriented along the axis of the hole (across the traces of rough machining on the hole surface). Along its growth path, corrosive pits caused by non-metallic inclusions were detected. It was these pits that determined the curvilinear propagation trajectory of the contact fatigue crack, which propagated from one pit to another. A significant portion of these inclusions, based on their elemental composition, are classified as corrosion-active non-metallic inclusions [13]. These non-metallic inclusions contributed to the active dissolution of both the inclusions themselves and the matrix phase in their vicinity when moisture entered the contact zone of the rivet surfaces and the holes in the disc crest. Taking into account the micro-displacements of the rivets relative to the hole surfaces in the disc, these local structural defects facilitated the formation of a network of fine microcracks initiated from them.

Figure 4. Traces of rough machining on the inner surface of a rivet hole formed during the disc manufacturing stage, and the curved trajectory of a contact fatigue crack propagating along the axis of this hole (a, in the upper photo), as well as typical features of macro-fractures in the bridges between the closest rivet holes in the crest of the steam turbine rotor disc (b)

Macro-level analysis of the fractures in the bridges between the rivet holes showed that all failures began in the form of angular segmental cracks on the steam inlet side of the stage (Fig. 4). Their relatively smooth morphology at the initial stage typically ended in a rough final fracture with characteristic brittle tear ridges, corresponding to the overload stage upon reaching a critical state.

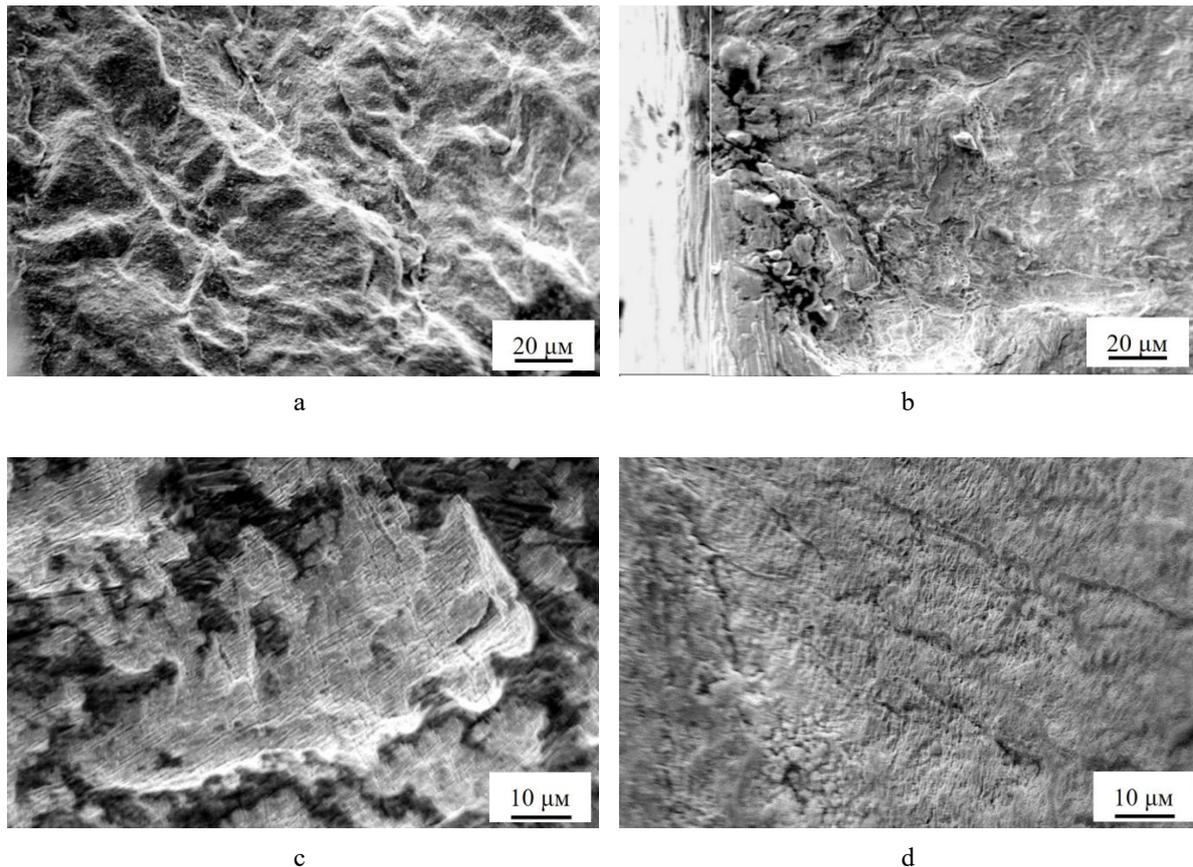
microscopic level (Fig. 5 a). This was considered direct proof that the fractures were exposed to the high-temperature process medium for a long period, and therefore, their formation did not occur instantaneously due to overload but over a long period of the disc's service life. However, even in this state, quarter-circular marks were visible on the fractures, densely decorated with rows of circular pits (up to 5 μm in diameter), which formed due to the corrosive interaction of non-metallic inclusions with the process medium. The same pits decorated the front of the propagating fatigue crack at each subsequent stage of its growth. Based on this, it was concluded that inclusions in the steel structure (as a result of imperfections deoxidation process, incomplete homogenization of the solid solution, etc.) play a decisive role in reducing its fracture resistance.

Figure 5. Typical fractograms of fractures of the bridges between the holes in the disc crest at the fracture initiation stage by the contact fatigue mechanism (a, b) and at the stage of further propagation of a fatigue crack by the fatigue striation mechanism (c, d)

Even partial cleaning of the fractures revealed a series of parallel cracks on the surface of the rivet disk hole, visualised by opening their edges (Fig. 5 b, parallel steps in the lower left corner of the fractogram). Secondary cracks, decorated with

non-metallic inclusions, are clearly visible on the fractures of the disk crest. These cracks are traces of contact fatigue cracks, propagating from the surface of the rivet holes to their intersection with the fracture surface. These secondary cracks were not considered to be traditional branches of the crack in the direction of its propagation, which, as a rule, relax the stress at their tips and slow down their growth. However, these cracks most likely represented alternative fracture initiation pathways from the hole surface, intersecting the fracture but behind the main fracture front. In our case, this is an effective way to visualise contact fatigue cracks in the fractures of the bridges between the rivet holes.

After repeated cleaning of the fractures, it was possible to confirm that the crack initiation stage via the contact fatigue mechanism from the rivet hole surfaces in the disc crest gradually transitions to its propagation via the high-cycle fatigue mechanism. According to the results of the analysis of the fracture of the bridge between the holes in the damaged fragment of the disc crest at the stage of the angular quarter-circular crack propagation from the steam inlet side, typical signs of fatigue failure were discovered (Fig. 5 c, d). The most important of these was the presence of parallel rows of fine fatigue striations located across the festoons, extending in the main direction of fatigue crack propagation. These striations were the traces of the crack's stage-by-stage advancement during each load cycle of the disc.
