ESTIMATION OF THE PIPELINES WORKING CAPACITY BASING ON THE RESULTS OF SEMIMODE TESTING

Andrii Kychma¹; Josyp Luchko²

Summary. Analysis of the state of arts of estimation the pipelines operation capacity in Ukraine and other countries taking advantage of the technology of pipeline pigging and integrity management (PPIM and ILI technology) has been carried out. Basing on the results of semimodel testing, some aspects of estimation of defects of pipe metal are considered. The load-bearing capacity of a segment of a pipeline with elastic-plastic deformation, which had been detected during the inside-pipeline diagnostics of a long-time operating gas pipeline of the outer diameter 1220 mm has been experimentally investigated. The paper presents some particularities of experimental estimation of the pipeline segment strength in zones of local plastic deformation. The stress-strain state of locally plastically deformed segments of the pipeline has been determined using the semimodel testing. Basing on the investigations, recommendations for engineering practice are proposed.

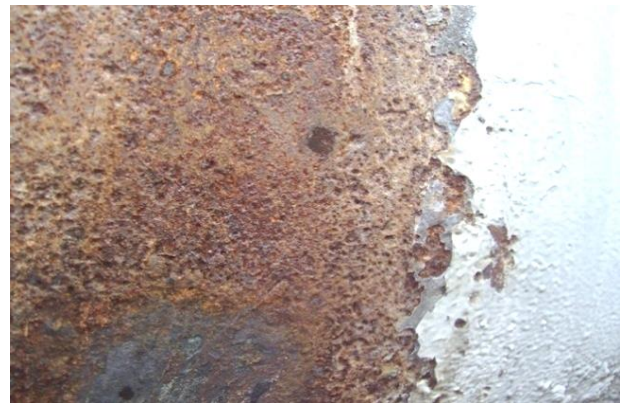
- the defects of the circular weld seam – 107 (which makes 52,7 %);
- the defects of the longitudinal weld seam – 4 (%);
- mechanical defects – 7 (3,5 %);
- corroding defects – 85 (41,8 %) (Fig. 3).

Figure 3. Corroding defects detected using the inside-pipeline diagnostics

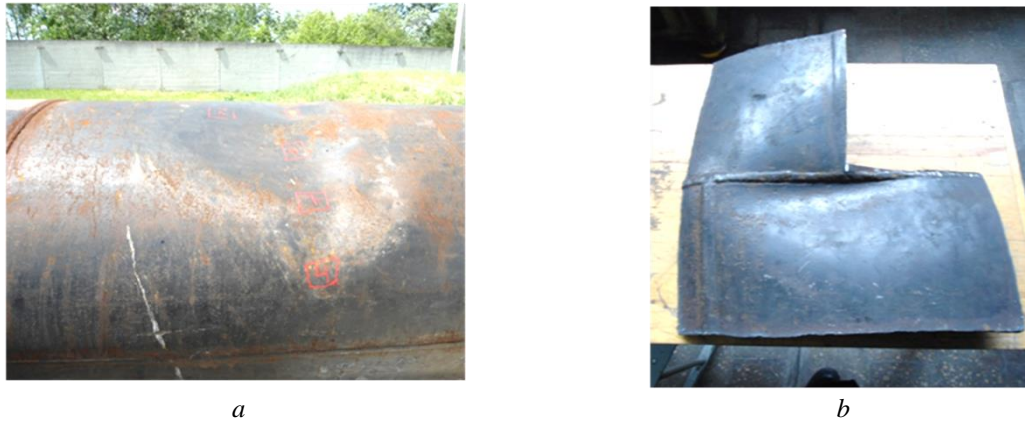
The analysis of the results of the inside-pipeline diagnostics shows, that about 23 % of the corroding damages can be presented as the semi-elliptic type of rotation. During the preliminary operations at the gas-transporting system “Ivatsevychi – Dolyna” near the CS “Birka” two areas of the pipeline were revealed, where the deflections of cross-sections from the ideal circular shape were sufficient enough. The investigations of these areas in the pits showed, that the pipeline broaching in the hill-side, being supported by the rock plate, has the dents of the semi-elliptic type of the 300 x 200 mm size and 65 mm depth (Fig. 4 a) and (Fig. 4 b).

Figure 4. The plastic deformation areas of pipeline detected using the inside-pipeline diagnostics:
a – deformation of pipe body; *b* – deformation of metal in the areas of weld seams

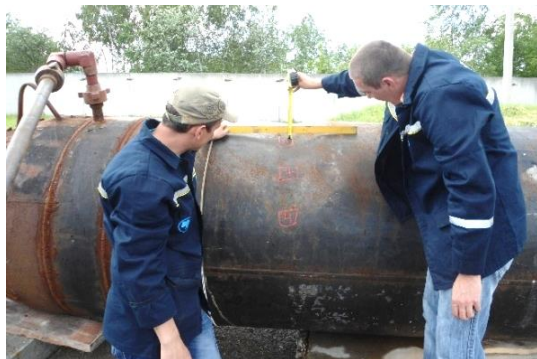
Estimation of the bearing capacity of the test reservoir. The test pressure reservoir was subjected to the hydraulic testing by the static pressure. The creation of the additional pressure, created by water, was formed by the plunger pump of the blowing pump unit A-30, mounted on the car “Kraz” undercarriage. The pressure of the reservoir was measured by the manometer MO. The blowing pump unit was able to create the additional pressure in the reservoir to 30 MPa. The pressure P in the reservoir being increased step-by-step with the $\Delta P=1$ MPa step, the change of the dent depth was controlled (Fig. 6). After that the weld joints were controlled visually. The parameters of the stress state were recorded too using the measuring device “MESTR-411” and the segment metal hardness – by the wearable electronic hardness tester “ТЕМІІ-3”. The measurement were taken a number of times and their average values were found.

**Figure 6.** Monitoring of the dentdepth during the reservoir test

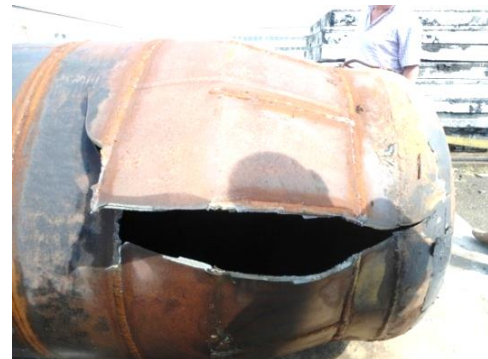
The fracture of the test reservoir was detected, when the inside pressure reached 10,0 MPa (Fig. 7). The dent area in the pipe segment (5) almost reached its original (non-deformed) place (Fig. 8). The decrease of the maximum dents deflection under different pressures in the test reservoir is presented on Table 4.

**Figure 7.** Segment of fractured test reservoir

The biaxial stress state under the elastic and plastic deformation of the test pressure reservoir pipes, that is, the state of the deformed area of the pipe with a dent, and the process of the reverse deformation of the segment wall under the internal pressure were investigated experimentally. During semimodel tests the investigated reservoir was damaged on the weld joint cross-sections, the total stress concentrator of which were the cross-section of the ring seam of the 1220 mm outer diameter and one of the longitudinal seams of the cone-shaped adapter of 1200 mm × 1200 mm outer diameter (Fig. 7).

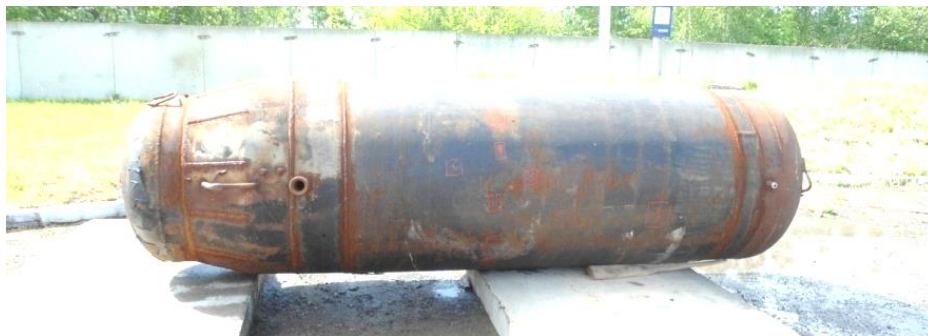
**Figure 8.** Appearance and shape of pressure reservoir after testing
