Scientific Journal of the Ternopil National Technical University
2026, vol. 122, no. 2, pp. 63–69,
ISSN: 2522-4433 Print, ISSN: 2522-4441 Online
https://doi.org/10.35784/ visnyk_tntu2026.02.063

Features of the fracture of the control valve rod of a thermal power plant steam turbine

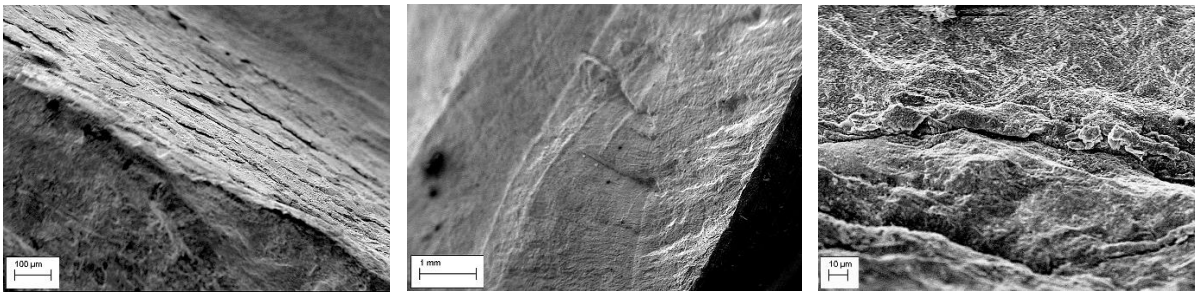
Microfractographic analysis showed that the initiation of a crack in the rod occurred in several places along its perimeter from damage in the surface nitrided layer in the area of the fillet transition between the conical part of the rod and its head (Fig. 1). Damage in the nitrided

layer spread to its entire depth (up to 200 μm) and caused a high concentration of stresses. This created favorable conditions for the propagation of fatigue cracks in the main metal of the rod. Macro-detail of the fracture indicates that fatigue is responsible for the rod failure. Secondary cracks were observed along almost the entire perimeter of the rod at the transition, which is a sign of weak adhesion between them, which was associated with internal oxidation (Fig. 1c).

Figure 1. (**a**, **b**) Crack initiation in different zones around the rod perimeter; (c) secondary cracks on the fracture surface.

The fracture of the rod was analyzed macro-fractographically, and it was found that it collapsed due to multiple microcracks in the nitrided layer along the perimeter of the rod, in the fillet transition zone between its conical part and the head, which acts as a stress concentrator. Further, the crack growth occurred in the depth of the section with the merging of the fronts of separate cracks from the surface and the final spontaneous failure of the rod.

Thus, based on the study of the microfractographic features of the control valve rod fracture, it was concluded that it occurred as a result of the nucleation of circular microcracks in the nitrided layer due to its internal oxidation and the destruction of the partitions between the oxidized areas due to cyclic loading of the rod caused by vapor pressure drops, flow turbulence and resonance phenomena, when the natural frequency of oscillations of the rods coincides with the frequency of oscillations caused by the influence of technological factors. The high concentration of stresses at their tops, low resistance to high-temperature oxidation, and matrix destruction (due to the release of chromium carbides and a decrease in its content in the matrix) contributed to their germination into the rod base by the mechanism of multi-cycle fatigue. If the niobium present in the steel composition had performed its assigned function (to prevent a decrease in the chromium content in the matrix), the rod resource would have been much greater. Therefore, in the future, to prevent unforeseen damage to such critical structural elements as rods, incoming inspection of the steel structure is recommended.

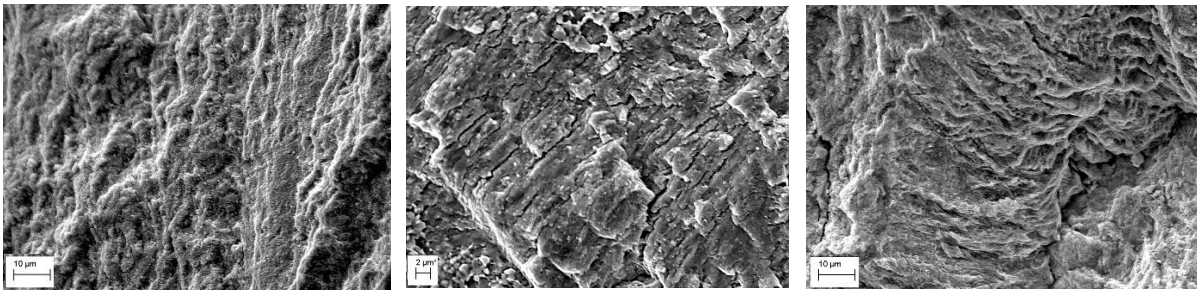
Within the nitrided layer, fatigue failure of the partitions between the fragments separated from the matrix by internal oxidation occurred, with the formation of a grooved relief oriented parallel to the outer surface of the rod and with signs of secondary cracking (Fig. 2 a). In areas corresponding to decohesion zones due to internal oxidation, traces of corrosion effects on the interphase boundaries between the matrix and inclusions of various nature were identified.

Figure 2. Microfractograms of rod fracture: (a) in the area of the surface nitrided layer; (b) at the stage of stable fracture propagation; (c) in the crack growth zone with high asymmetry of the loading cycle (at the stage of low-cycle fatigue).

At the initial stage of the transition of the fracture to the base metal, fatigue cracks originated from the blunted crack tip in the nitrided layer by forming a smooth relief with barely noticeable fatigue grooves. By the step of the grooves, it was established that at the initial stage of crack growth in the rod, their speed was 5·10-8 m/cycle. With increasing crack length, the contours of the grooves became increasingly clear, their step became larger, and the festoons, the surface of which was covered by the grooves, became more

relief. These are signs of an increase in the crack growth rate. The classical groove mechanism of fatigue failure was preserved in most of the rod fractures, which is usually considered a sign of multi-cycle fatigue (Fig. 2 b). Of course, the deeper the fracture spread from the lateral surface of the rod, the greater the pitch of the grooves, the deeper and clearer the secondary cracks that decorated them, and the greater the relief of the festoons.

Fatigue fracture in the base metal occurred with significant signs of plastic deformation, delamination, formation of chevron patterns, and track marks (Fig. 2c). It was assumed that the prerequisites for such a fracture arose due to the deepening of cracks in other places along the perimeter of the rod under conditions of multi-cycle fatigue. As a result of low-cycle fatigue, only the alignment of the fracture front occurred.
